80960Cx Processor

Specification Update

October 1998

Order Number: [272875-004](#)

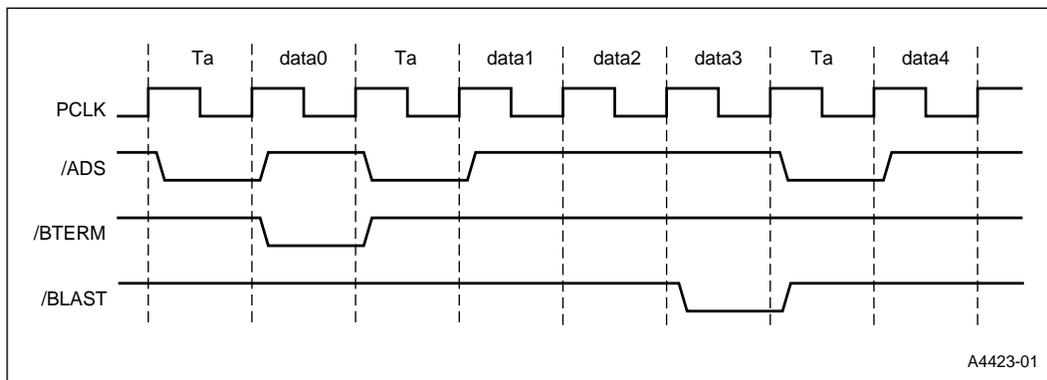
Figure 1. Timings for Correct Operation

If BTERM# is asserted during data(0), then ADS# will be asserted again for data(1) and the access will end by asserting BLAST# while reading data(3).

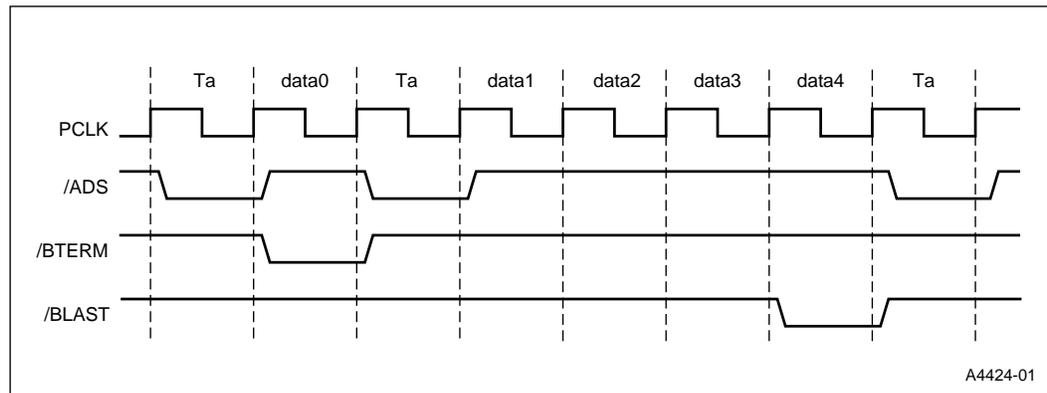
Figure 2. Timings for Incorrect Operation

Incorrect Operation

The access spans over data3. For example, BLAST# is asserted while data4 is read.

Implication: Memory and I/O systems must accept these forms of access when using BTERM.
