## 82527

**Specification Update**

June, 1998

Order Number: 272876-002

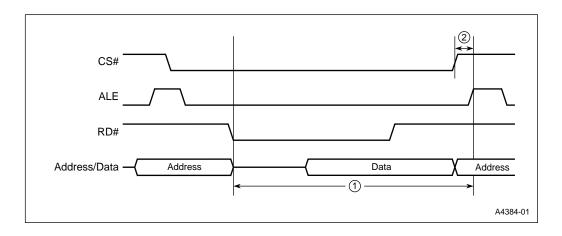
Figure 1. Bus Cycle for Mode 0 or Mode 1 Operation (Read Cycle)

For mode 0 and mode 1 (Intel multiplexed modes), the control signals ALE, RD# and WR# are used to define the address and whether the cycle is a data read or write operation. The ALE signal is commonly used to latch the address information and generate a CS# signal to the 82527. The problem occurs in this configuration when the next cycle ALE is asserted before CS# of the current cycle becomes invalid. This circumstance presents a problem only when CS# is active and the next cycle's ALE occurs less than 1.5  $t_{MCLK}$  after the current cycle's RD# low. ( $t_{MCLK} = t_{OSC}/[(1 + DSC \text{ bit}) + DMC \text{ bit}]$  where DSC = Divide System Clock, DMC = Divide Memory Clock.

When performing "fast reads" associated with the double-read operation in mode 0 or 1, one of the following two conditions must be true:

- 1. The time from RD# low of the current cycle to the next ALE must be greater than 1.5  $t_{MCLK}$ , or
- The CS# signal to the 82527 must be inactive before the next occurrence of an ALE, when the time from the RD# low of the current cycle to the next cycle's CS# active is less than 1.5 t<sub>MCLK</sub>.

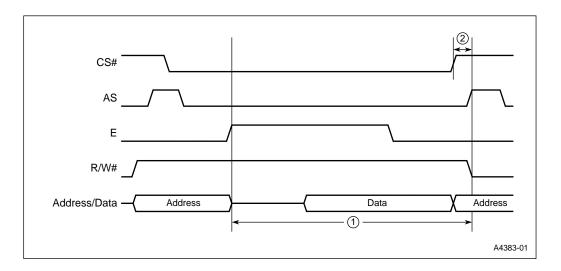
Figure 2. Bus Cycle for Mode 2 Operation (Read Cycle)

For Mode 2, the control signals AS, R/W#, and E are used to define the address, to specify whether the cycle is a data read or write operation, and to synchronize the memory accesses. The AS signal is commonly used to latch the address information and generate a CS# signal to the 82527. The problem, as outlined for Modes 0 and 1, occurs when the next cycle's AS is asserted before CS# of the current cycle becomes invalid. This circumstance presents a problem only if the next cycle's AS occurs in less than  $1.5~t_{\rm MCLK}$  after the current cycle's E low while CS# is still active.

For Mode 2 operation, one of the following two criteria must be true:

- 1. The time from E high of the current cycle to the next AS must be equal to or greater than  $1.5\ t_{MCLK}$ , or
- 2. The CS# signal to the 82527 must be inactive before the next occurrence of an AS, when the time from E high of the current cycle to the next cycle CS# active is less than 1.5 t<sub>MCL.K</sub>.

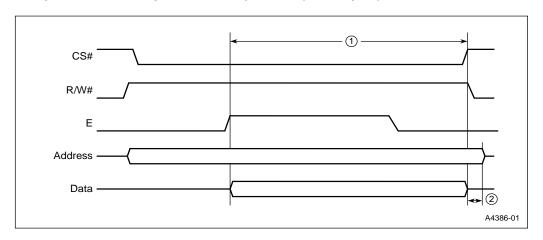
Figure 3. Bus Cycle for Mode 3 Synchronous Operation (Read Cycle)

For mode 3 synchronous operation, there is no ALE or AS signal. Mode 3 is the demultiplexed mode of the 82527. For this mode, the address information must be present through the entire cycle. However, when performing fast read operations, similar considerations as the other modes must be observed to prevent problems when performing reads from the 82527.

For mode 3 synchronous operation, one of the following two criteria must be true:

- 1. The time from E high of the current cycle to CS# invalid must be equal to or greater than 1.5  $t_{MCLK}$ , or
- 2. Address information must remain valid on the bus until after CS# goes inactive.

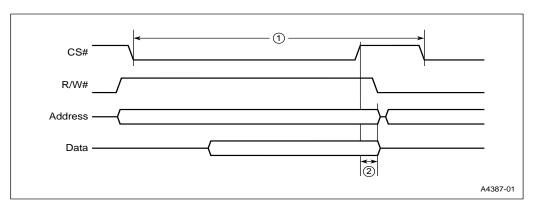
Figure 4. Bus Cycle for Mode 3 Asynchronous Operation (Read Cycle)

Mode 3 asynchronous is also a demultiplexed mode of operation on the 82527. This mode is typically used with the DSACK0# signal. When using mode 3 asynchronous with host CPUs that do not have the DSACK0# input, the following considerations must be observed to prevent problems when performing reads of the 82527.

For Mode 3 asynchronous (no DSACK0#), both of the following criteria must be true:

- 1. The time between consecutive CS# cycles must be equal to or greater than 2 t<sub>MCLK</sub>.
- 2. Address information must remain present on the bus until after CS# goes inactive.
