# **Pentium® II Xeon™ Processor Specification Update**

Release Date: February 1999

Order Number: 243776-010

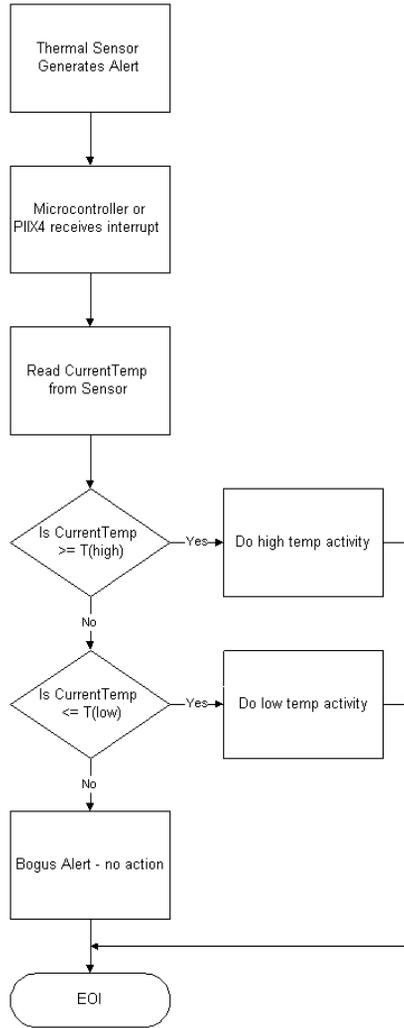
Figure 2. Workaround Flowchart: SMBALERT#-Driven System

### D30. Thermal Sensor May Assert SMBALERT# Incorrectly

Under the conditions described below, the thermal sensor incorrectly generates the SMBALERT# interrupt. *All* of the following conditions must be met to trigger a false interrupt:

**WORKAROUND:** Three different (mutually exclusive) workarounds are possible:

1. Before servicing an interrupt from the thermal sensor, read and compare the processor thermal reading with the threshold limits ( $T_{HIGH}$  or  $T_{LOW}$ ). Figures 2 and 3 provide basic flowcharts for the implementation of this workaround in an interrupt driven system.
2. If the firmware implemented polls the Status Register only, then before taking any action, re-read the temperature register and do a comparison with the alarm threshold limits ( $T_{HIGH}$  or  $T_{LOW}$ ) to determine if the value is actually still within the temperature window.
3. Use a temperature polling scheme to monitor the processor temperature.
