Pentium® II Xeon™ Processor Specification Update

Release Date: March 1999

Order Number: 243776-011

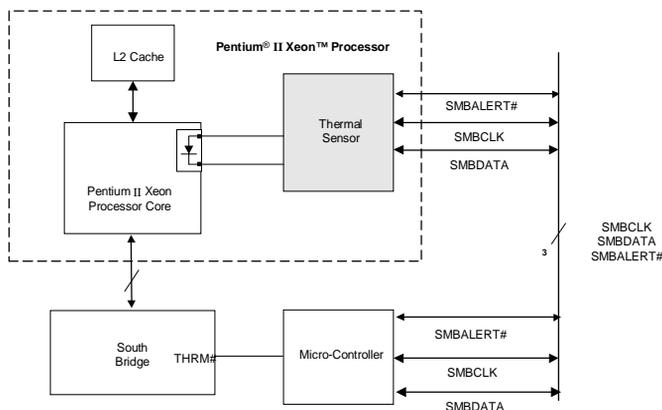
Figure 1. An Example of Microcontroller Driven Thermal Management

D30. Thermal Sensor May Assert SMBALERT# Incorrectly

PROBLEM: The Pentium II Xeon processor has a thermal sensor that monitors the processor core's temperature. The thermal sensor asserts SMBALERT# if the processor temperature exceeds the temperature limits set in the Alarm Threshold Registers (T_{HIGH} , T_{LOW}). It also sets the corresponding Status Register bits to identify the cause of the interrupt. Figure 1 gives one example of the how the SMBALERT# signal could be used in a system.

Under the conditions described below, the thermal sensor incorrectly generates the SMBALERT# interrupt. *All* of the following conditions must be met to trigger a false interrupt:

WORKAROUND: Three different (mutually exclusive) workarounds are possible:

1. Before servicing an interrupt from the thermal sensor, read and compare the processor thermal reading with the threshold limits (T_{HIGH} or T_{LOW}). Figures 2 and 3 provide basic flowcharts for the implementation of this workaround in an interrupt driven system.
2. If the firmware implemented polls the Status Register only, then before taking any action, re-read the temperature register and do a comparison with the alarm threshold limits (T_{HIGH} or T_{LOW}) to determine if the value is actually still within the temperature window.
3. Use a temperature polling scheme to monitor the processor temperature.
