Pentium® II Xeon™ Processor Specification Update

Release Date: April 1999

Order Number: 243776-012

The Pentium® II Xeon™ processor may contain design defects or errors known as errata which may cause the product to deviate from published specifications. Current characterized errata are documented in this Specification Update.

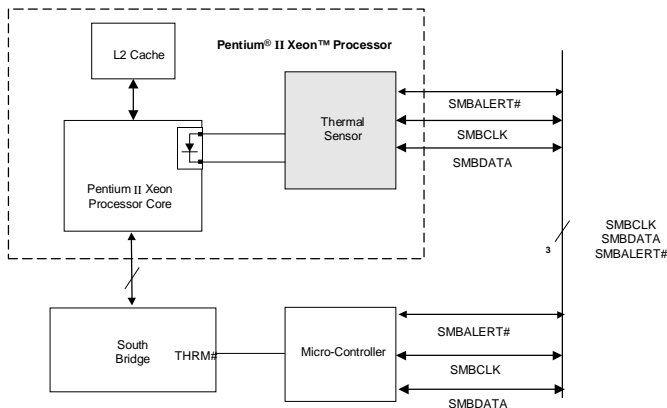
Figure 1. An Example of Microcontroller Driven Thermal Management

D30. Thermal Sensor May Assert SMBALERT# Incorrectly

PROBLEM: The Pentium II Xeon processor has a thermal sensor that monitors the processor core's temperature. The thermal sensor asserts SMBALERT# if the processor temperature exceeds the temperature limits set in the Alarm Threshold Registers (T_{HIGH} , T_{LOW}). It also sets the corresponding Status Register bits to identify the cause of the interrupt. Figure 1 gives one example of the how the SMBALERT# signal could be used in a system.

Under the conditions described below, the thermal sensor incorrectly generates the SMBALERT# interrupt. All of the following conditions must be met to trigger a false interrupt:

WORKAROUND: Three different (mutually exclusive) workarounds are possible:

1. Before servicing an interrupt from the thermal sensor, read and compare the processor thermal reading with the threshold limits (T_{HIGH} or T_{LOW}). Figures 2 and 3 provide basic flowcharts for the implementation of this workaround in an interrupt driven system.
2. If the firmware implemented polls the Status Register only, then before taking any action, re-read the temperature register and do a comparison with the alarm threshold limits (T_{HIGH} or T_{LOW}) to determine if the value is actually still within the temperature window.
3. Use a temperature polling scheme to monitor the processor temperature.
