Intel[®] Pentium[®] II Xeon[™] Processor Specification Update

Release Date: November 2001

Order Number: 243776-031

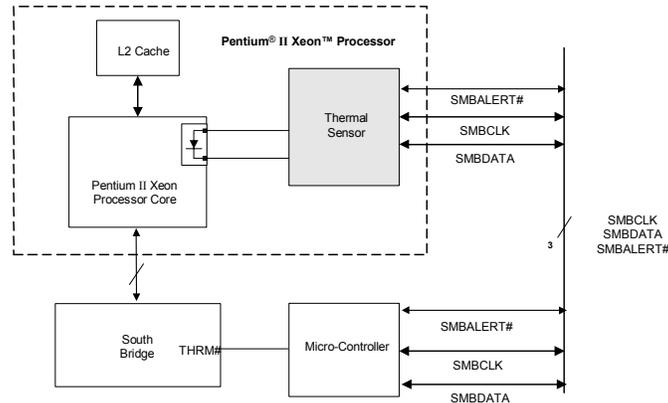
Figure 1. An Example of Microcontroller Driven Thermal Management

Problem: The Pentium II Xeon processor has a thermal sensor that monitors the processor core's temperature. The thermal sensor asserts SMBALERT# if the processor temperature exceeds the temperature limits set in the Alarm Threshold Registers (T_{HIGH} , T_{LOW}). It also sets the corresponding Status Register bits to identify the cause of the interrupt. Figure 1 gives one example of the how the SMBALERT# signal could be used in a system.

Under the conditions described below, the thermal sensor incorrectly generates the SMBALERT# interrupt. All of the following conditions must be met to trigger a false interrupt:

Workaround: Three different (mutually exclusive) workarounds are possible:

1. Before servicing an interrupt from the thermal sensor, read and compare the processor thermal reading with the threshold limits (T_{HIGH} or T_{LOW}). Figures 2 and 3 provide basic flowcharts for the implementation of this workaround in an interrupt driven system.
2. If the firmware implemented polls the Status Register only, then before taking any action, re-read the temperature register and do a comparison with the alarm threshold limits (T_{HIGH} or T_{LOW}) to determine if the value is actually still within the temperature window.
3. Use a temperature polling scheme to monitor the processor temperature
