Mobile Pentium® II Processor Specification Update

Release Date: April 1999

Order Number: 243887-009

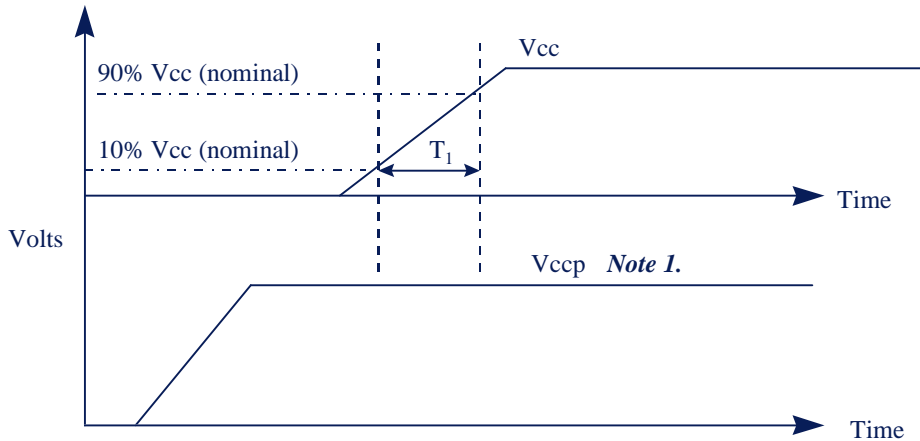
Figure 1. V_{CC}/V_{CCP} Timing Requirements (Mobile)

PROBLEM: The processor uses the PWRGOOD signal to ensure that no voltage sequencing issues arise; no pin assertions should cause the processor to change its behavior until this signal is asserted, when all power supplies and clocks to the processor are valid and stable. However, if V_{CC} ramps up before V_{CCP} , it will cause the processor to enter an invalid state.

IMPLICATION: If this erratum occurs, the system may boot normally however, the L2 cache may not be initialized.

WORKAROUND: For Mobile Pentium II processors, ensure that V_{CC} ramps after or with the L2 cache IO voltage (V_{CCP}). If V_{CCP} ramps after the V_{CC} , a delay circuit can be placed on the core V_{CC} to ensure that V_{CC} ramps at the same time or after V_{CCP} as shown below in Figure 1.

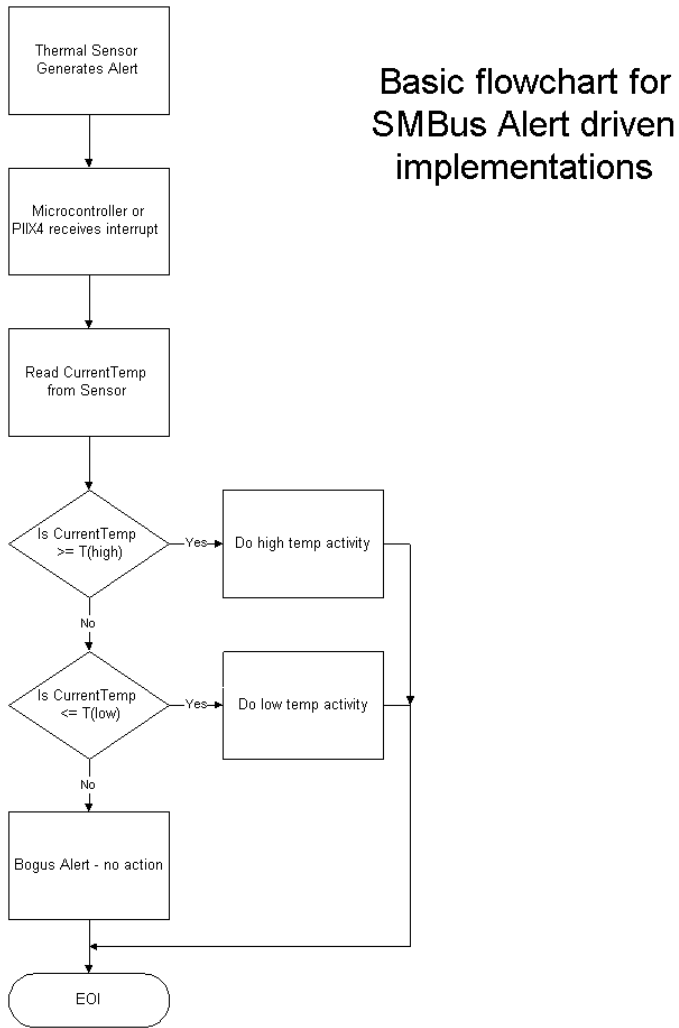
Figure 2. Workaround Flowchart: SMBALERT#-Driven System

Under the conditions described below, the thermal sensor incorrectly generates the SMBALERT# interrupt. *All* of the following conditions must be met to trigger a false interrupt:

1. Before servicing an interrupt from the thermal sensor, read and compare the processor thermal reading with the threshold limits (T_{HIGH} or T_{LOW}). Figures 2 and 3 provide basic flowcharts for the implementation of this workaround in an interrupt driven system.
2. If the firmware implemented polls the Status Register only, then before taking any action, re-read the temperature register and do a comparison with the alarm threshold limits (T_{HIGH} or T_{LOW}) to determine if the value is actually still within the temperature window.
3. Use a temperature polling scheme to monitor the processor temperature.

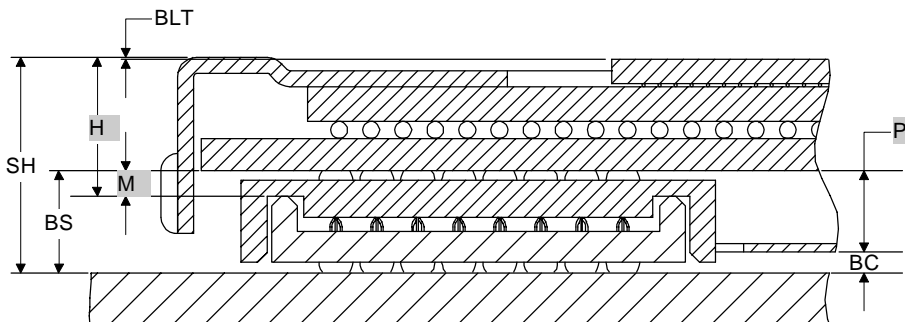
Figure 5.6. Cross Sectional View with Vertical Dimensions

B2. Misabeled Vertical Dimension Parameters

Figure 5.6 in the *Mobile Pentium® II Processor at 233 MHz, 266 MHz, and 300 MHz* datasheet should be replaced by the following figure:
