Mobile Pentium® II Processor Specification Update

Release Date: November 1999

Order Number: 243887-015

The Mobile Pentium® II processor or the Intel® Pentium® II Processor Mobile Module may contain design defects or errors known as errata which may cause the product to deviate from published specifications. Current characterized errata are documented in this Specification Update.

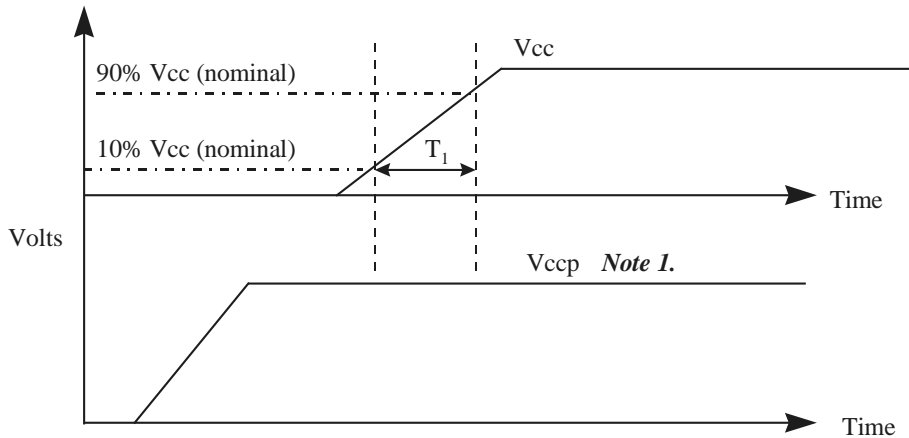
Figure 1. V_{CC}/V_{CCP} Timing Requirements (Mobile)

Problem: The processor uses the PWRGOOD signal to ensure that no voltage sequencing issues arise; no pin assertions should cause the processor to change its behavior until this signal is asserted, when all power supplies and clocks to the processor are valid and stable. However, if V_{CC} ramps up before V_{CCP} , it will cause the processor to enter an invalid state.

Implication: If this erratum occurs, the system may boot normally however, the L2 cache may not be initialized.

Workaround: For Mobile Pentium II processors, ensure that V_{CC} ramps after or with the L2 cache IO voltage (V_{CCP}). If V_{CCP} ramps after the V_{CC} , a delay circuit can be placed on the core V_{CC} to ensure that V_{CC} ramps at the same time or after V_{CCP} as shown below in Figure 1.

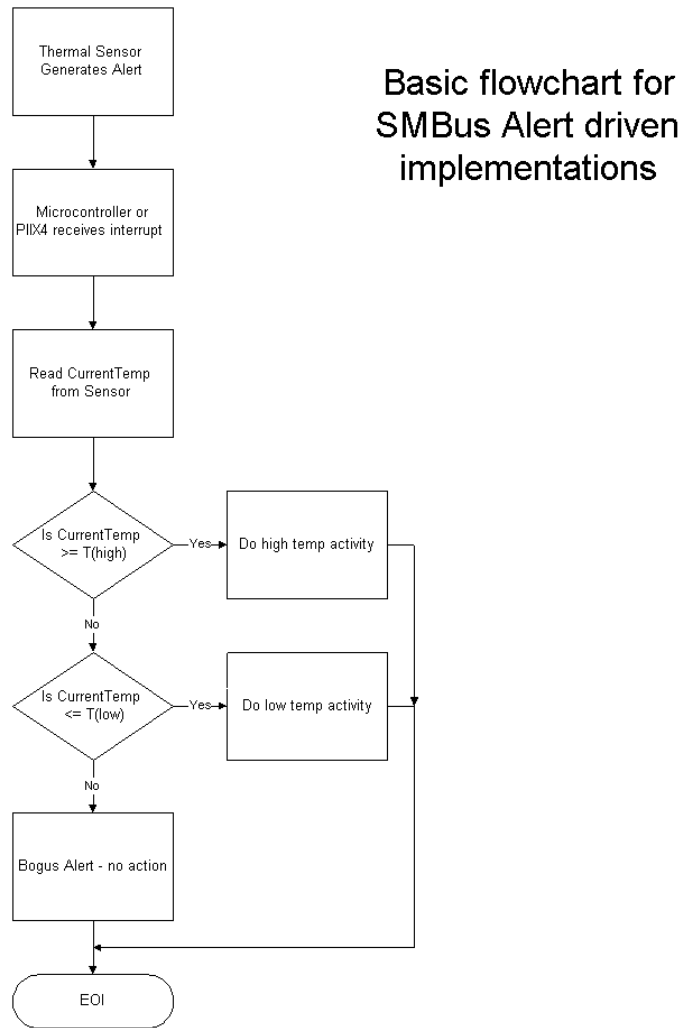
Figure 2. Workaround Flowchart: SMBALERT#-Driven System

Under the conditions described below, the thermal sensor incorrectly generates the SMBALERT# interrupt. All of the following conditions must be met to trigger a false interrupt:

1. Before servicing an interrupt from the thermal sensor, read and compare the processor thermal reading with the threshold limits (T_{HIGH} or T_{LOW}). Figures 2 and 3 provide basic flowcharts for the implementation of this workaround in an interrupt driven system.
2. If the firmware implemented polls the Status Register only, then before taking any action, re-read the temperature register and do a comparison with the alarm threshold limits (T_{HIGH} or T_{LOW}) to determine if the value is actually still within the temperature window.

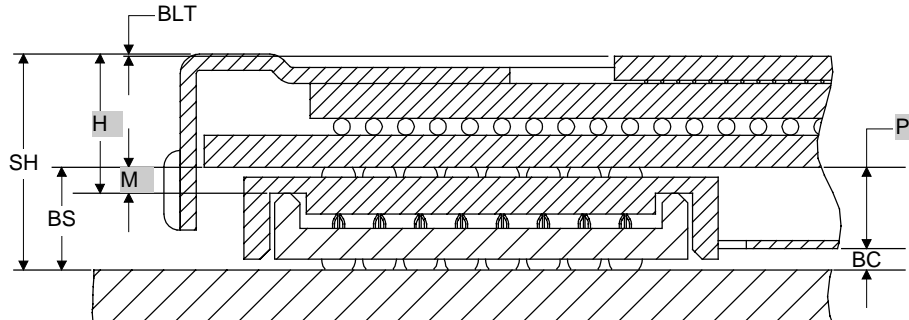
Figure 5.6. Cross Sectional View with Vertical Dimensions

B1. Mislabeled Vertical Dimension Parameters

Figure 5.6 in the *Mobile Pentium® II Processor at 233 MHz, 266 MHz, and 300 MHz* datasheet should be replaced by the following figure:

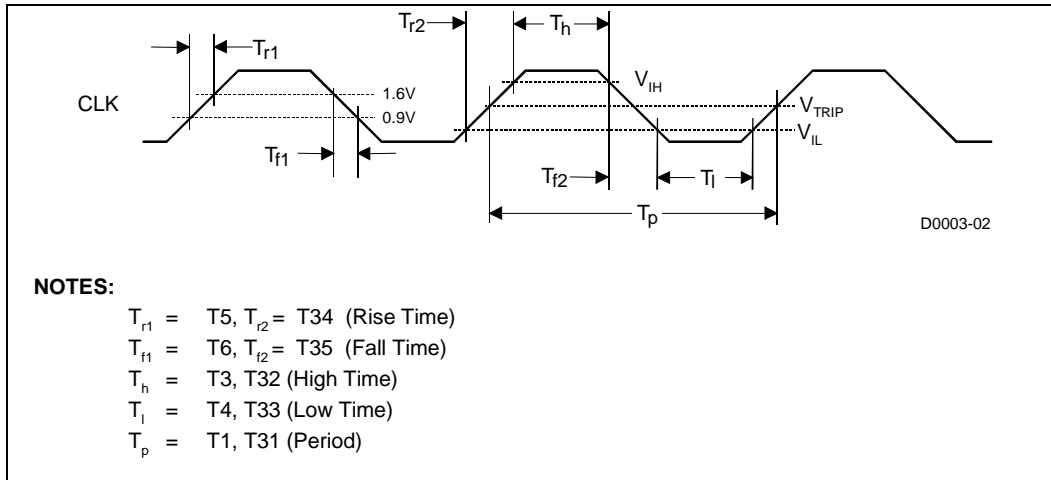
Figure 3.3 Generic Clock Waveform

B14. Generic Clock Waveform Figure

Figure 3.3 in *Mobile Pentium® II Processor in Mini-Cartridge Package at 366 MHz, 333 MHz, 300PE MHz, and 266PE MHz* datasheet (Order Number 245108), and the *Mobile Pentium® II Processor in BGA Package at 366 MHz, 333 MHz, 300PE MHz, and 266PE MHz* datasheet (Order Number 245106) has been updated. The following figure is to replace the ones in the above documents.

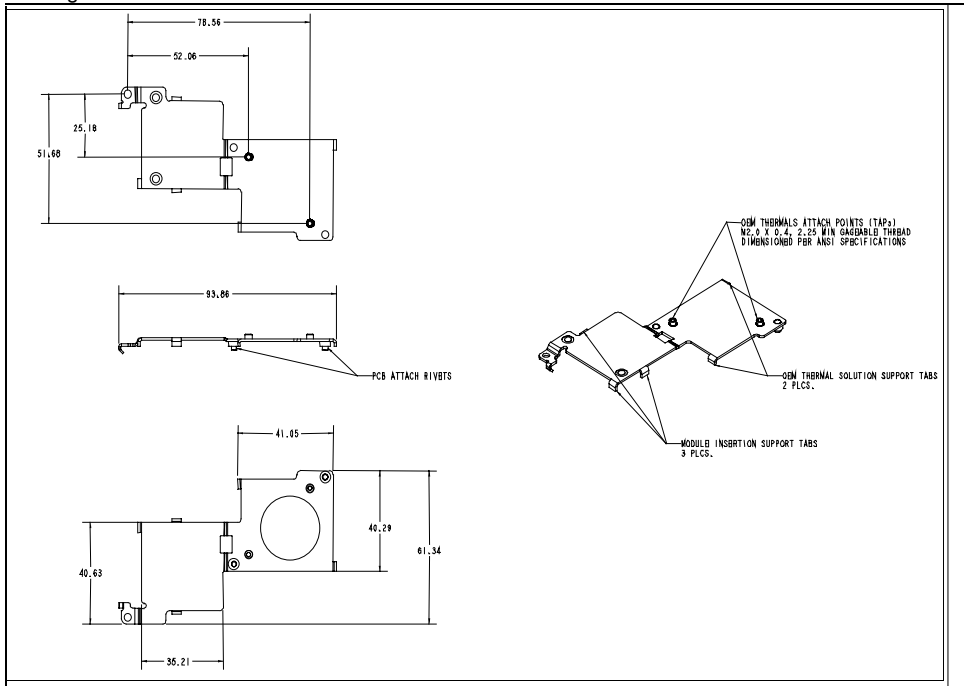
Figure 1. TAP Gageable Thread Clarification

OEM Thermal Attach Points (TAPs) M2.0 x 0.4, 2.25 min gageable thread dimensioned per ANSI specification.
