Intel[®] Pentium[®] III Processor Specification Update

Release Date: November 2001

Order Number: 244453-035

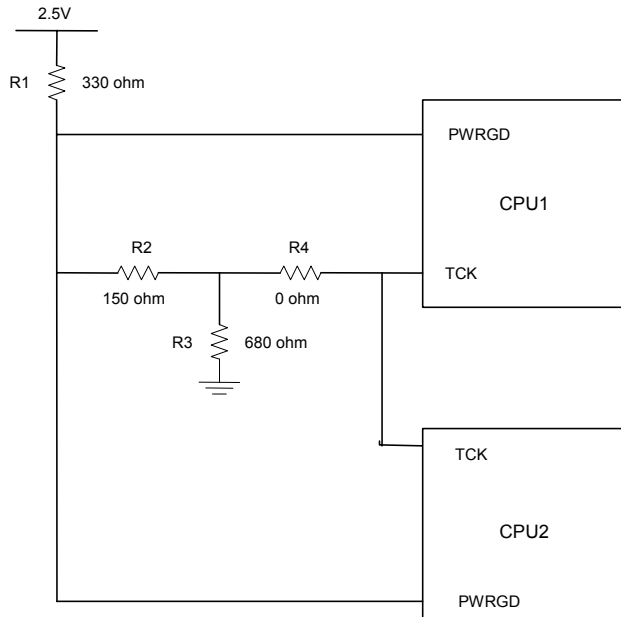
Pentium® III Processor with 512KB L2 Cache Platforms Workaround

Assumes the inputs to the CPU_PWRGD are open collector signals that are Wire-ANDed together

- The example workaround circuit assumes that the PWRGD inputs into the processors are open collector. Tying the PWRGD inputs together in a Wired-AND fashion allows each processor to receive PWRGD at the same time but at the latter of the 2 separate PWRGD assertions. If separation of the PWRGD inputs to each processor is required, extra circuitry will be required.
