Errata Report

**mP6TM MICROPROCESSOR
FOR WINDOWSTM SYSTEMS**

Preliminary

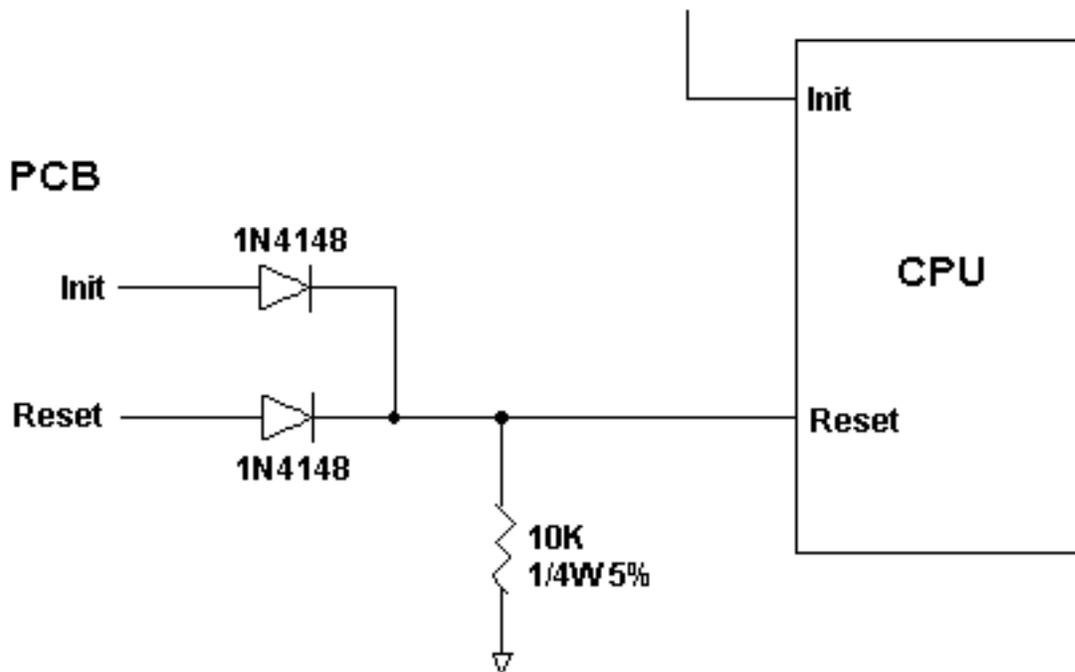
PROBLEM: System fails to boot with Rise™ mP6™ processor when STOPCLK is active during or shortly after RESET drops.

IMPLICATION: This problem has been observed only on the SMSC socket 7 motherboard with SLC90E42 Northbridge and SLC90E46 Southbridge at 2X mode; it has never been seen on a Super Socket 7 chipset.

WORKAROUND: Use a 2.5X ratio, or Run BIST at power on (refer to the modification below).

STATUS: There currently are no plans to fix this erratum. Expecting SMSC to change future chipset revision such that STOPCLK is not active during RESET.
