8XC196KC SPECIFICATION UPDATE

Release Date: May, 1997
Order Number: 272834-004

The 8XC196KC may contain design defects or errors known as errata. Characterized errata that may cause the 8XC196KC's behavior to deviate from published specifications are documented in this specification update.

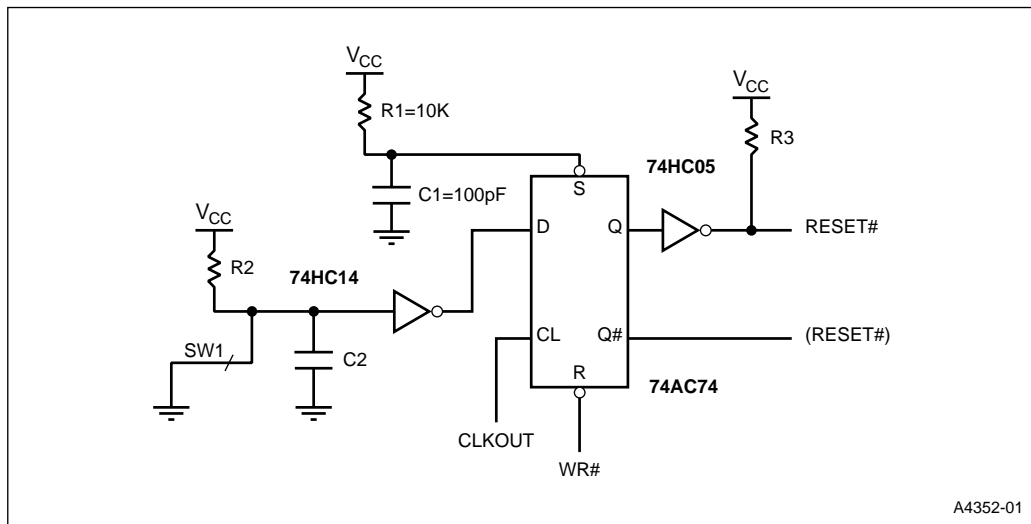
PROBLEM: The data bus floats asynchronously with RESET#. If reset occurs during an external write cycle, the contents of the external device may be corrupted. This is the normal operating condition for reset, and is not considered a bug. It is included on this list for those customers who may encounter corruption of data in external RAM during reset.

The following circuit will allow a manual reset to occur at the rising edge of CLKOUT only if WR# is high (inactive). If WR# is low (active) then RESET# will stay high (inactive). The 74HC14 and 74HC05 are usually already in the system, so the only additional components are the 74AC74, R1, and C1.

WORKAROUND: Allow reset to occur only at the rising edge of CLKOUT and only if WR# is high. If a reset occurs during an external bus write cycle, RAM data on the external bus may be corrupted. This describes a logic design that will alleviate the problem.

1. R1 = 10K ohms and C1 = 100 pF.
2. R2 and C2 should allow for reset state times plus write wait states.

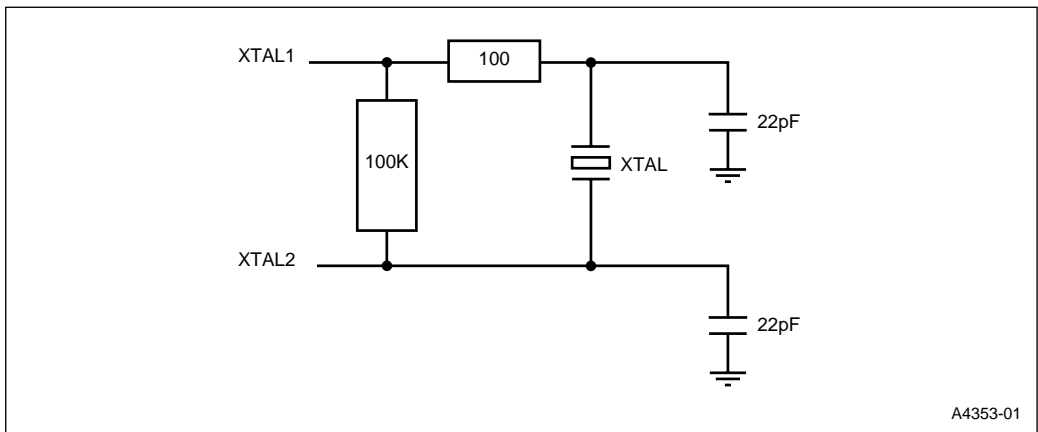
Figure 1. Options for Decreasing Noise Sensitivity

Under noisy conditions, microcontrollers with the problem may assume any one of three states:

More than 1.2 volts of peak-to-peak noise between internal V_{SS} and V_{SS1} may cause the oscillator to enter state 2 or state 3. A clean design with good decoupling minimizes the voltage difference between V_{SS} and V_{SS1} . Noise can be caused by both internal device switching and external circuitry.

IMPLICATION: Several customers have reported noise sensitivity when using the on-chip oscillator of the 80C196KC. Only devices with either no suffix after the topside tracking number or a "B" suffix are involved. Designs using an external oscillator are not affected. The B-3 stepping with a "C" suffix fixes the problem. All customers who use a crystal or ceramic resonator and do not follow the recommendations will be affected. Customers using an external oscillator will not be affected.

6. Decouple each V_{SS} and V_{SS1} pin to V_{CC} .
7. Place a 100 K resistor between XTAL1 and XTAL2. (See Figure 1.)
8. Place a 100 K resistor in series between XTAL1 and the crystal. (See Figure 1.)
9. Thoroughly test each system over its operating range.
10. Use an external oscillator if possible.

Some or all of these suggestions should allow the oscillator to function properly in a system. We have had no reported failures over commercial temperatures (0° to 70°C) in designs using suggestions 1 through 6.

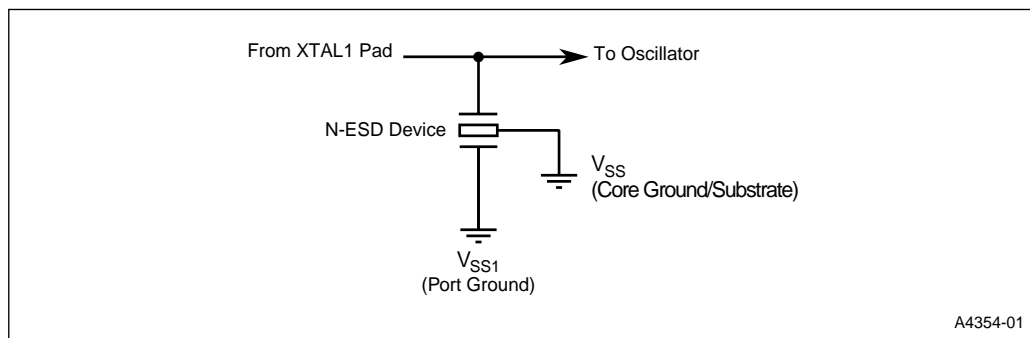
Figure 2. Internal ESD Protection

Every pin on the device has ESD (electrostatic discharge) protection designed into the chip. Figure 2 shows the standard cell for negative transient protection:

There are two grounds within the chip, core V_{SS} and port V_{SS1} . They are not tied together in the chip in order to isolate the core V_{SS} from noise on port V_{SS1} . Normally, noise on V_{SS} and V_{SS1} is decoupled externally by filter capacitors and a ground plane. If the grounding and decoupling are not sufficient, a voltage difference can occur between V_{SS} and V_{SS1} . From Figure 2, one can see that when V_{SS1} is around 0.6 volts negative with respect to V_{SS} , the protection device can start to turn on. The resulting current is well below the leakage specs for the I/O pins and has negligible effect except on the extremely high impedance XTAL1 input.

This minute leakage may cause the DC bias level on XTAL1 to decrease, resulting in reduced gain in the oscillator stage. The oscillation magnitude decreases from the normal rail-to-rail transitions to the point that it may not trigger the internal clocks. CLKOUT then stops or exhibits missing transitions and a decrease in frequency. The signal at XTAL2 drops to about 1.5 volts peak-to-peak centered around 3.5 volts ($V_{CC} = 5$ volts). The impedance of the internal 2 M-ohm resistor between XTAL2 and XTAL1 is too large to return the oscillator bias level to the region of maximum gain.

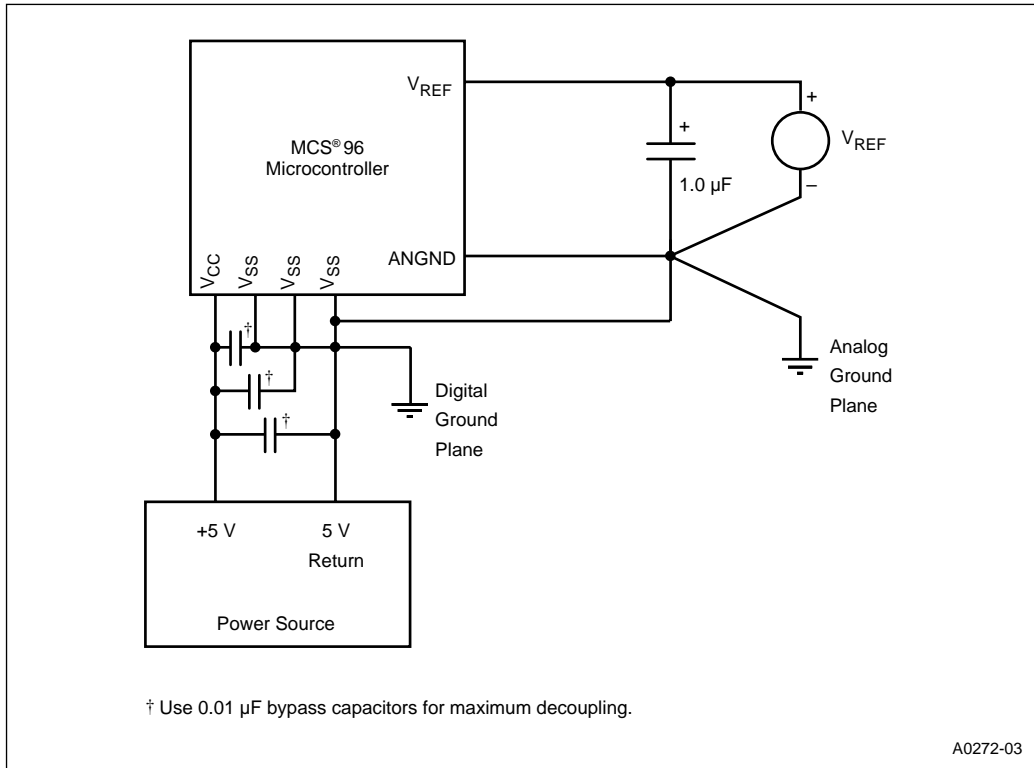
006. Page 11-3

PROBLEM: In Figure 11-2, the recommended capacitor value between V_{CC} and V_{SS} is 0.01 μF or greater. Also the recommended capacitor value between V_{REF} and ANGND is 1.0 μF .

Section 11.2.1 explains the reason for these capacitors. However, the second to last line of the first paragraph should read as follows: 'Connect a 0.01- μF bypass capacitor between V_{CC} and each V_{SS} pin and a 1.0- μF capacitor between V_{REF} and ANGND.'

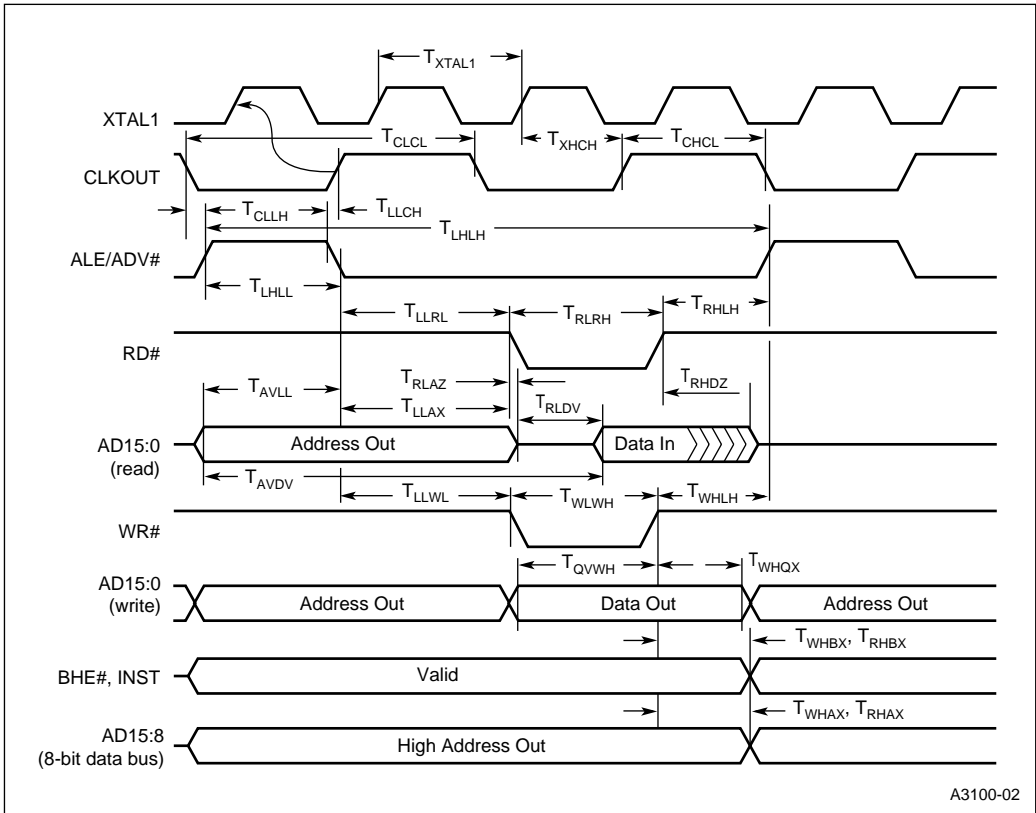
009. Page 13-22

PROBLEM: Figure 13-20 displays the system bus timing. However, there are a couple of mistakes. First, the WR# signal shows a range for the transition from high to low. This is incorrect; it should be a single line. Next, the signal labeled BUS should not refer to 16-bit mode only. This BUS signal shows AD0-7 in 8-bit mode and the entire bus (AD0-15) in 16-bit mode. The corrected diagram is as follows:

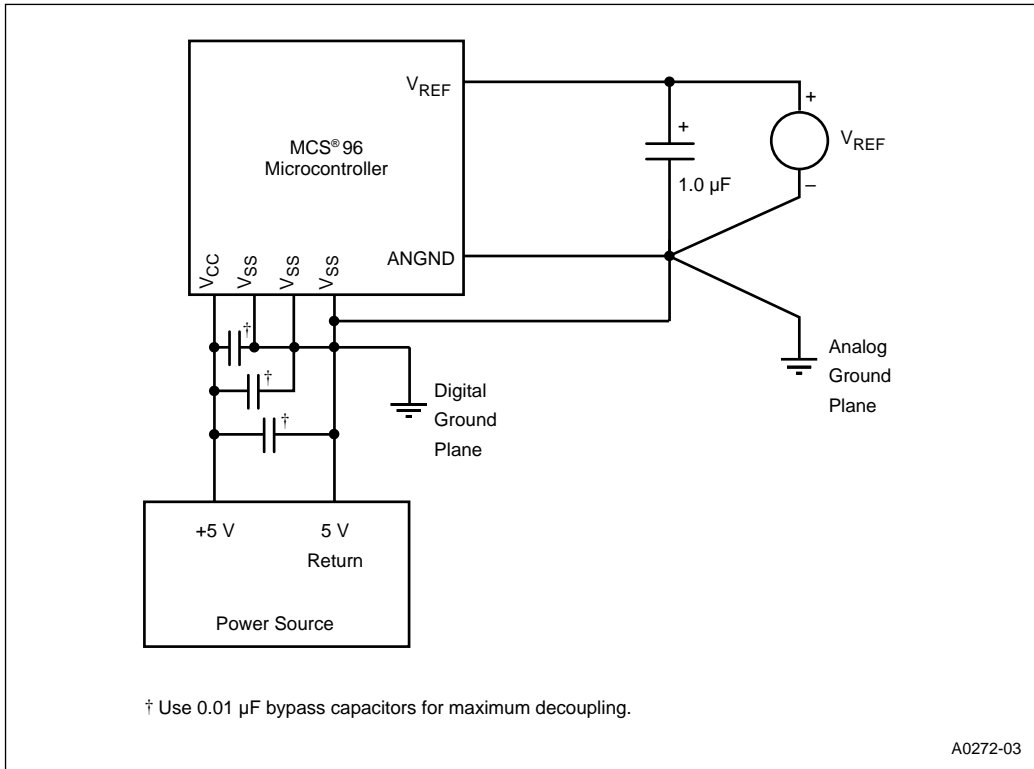
026. Page 11-3

ITEM: In Figure 11-2, the recommended capacitor value between V_{CC} and V_{SS} is **0.01 μF** or greater. Also, the recommended capacitor value between V_{REF} and ANGND is **1.0 μF** . The following figure replaces Figure 11-2:

In Section 11.2.1, the reason for these capacitors is explained. However, the second to last line of the first paragraph should read as follows:

‘Connect a 0.01- μF bypass capacitor between V_{CC} and each V_{SS} pin and a 1.0- μF capacitor between V_{REF} and $ANGND$.’

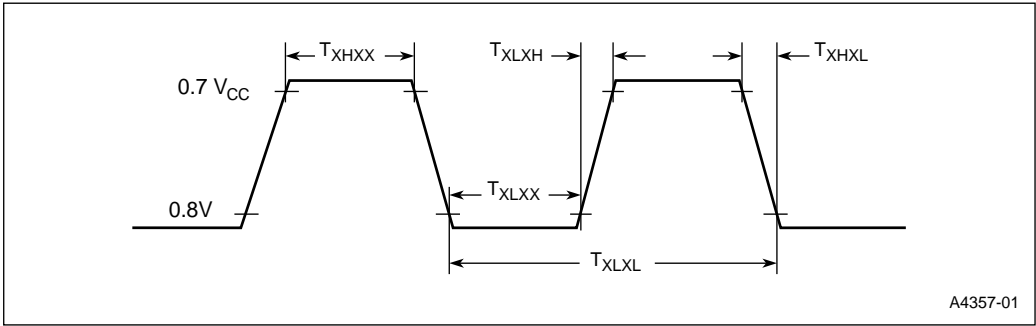
Figure 11-6. External Clock Drive

ITEM: In Figure 11-6, the timing diagram incorrectly represents the T_{XLXL} and T_{XHXL} timing specifications. The timing diagram below replaces Figure 11-6.

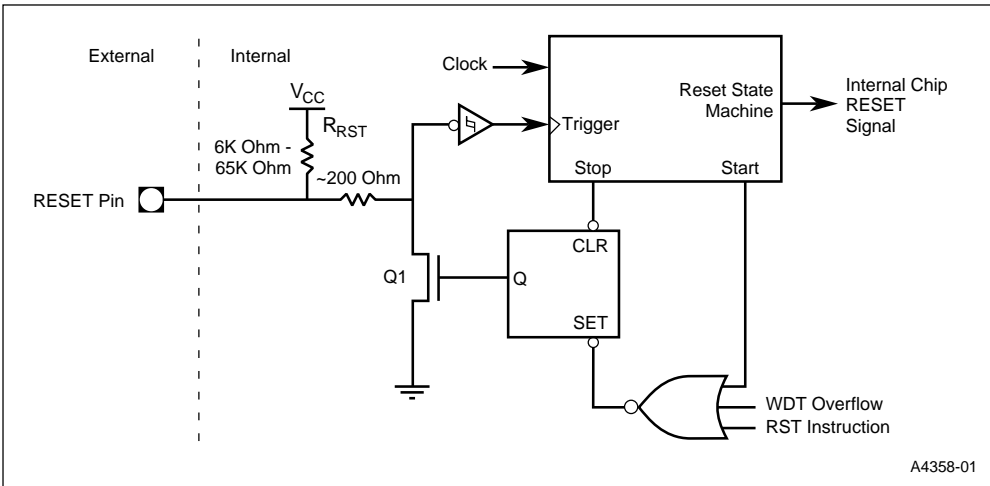
Figure 11-8. Reset Pin Internal Circuit

ITEM: Figure 11-8 shows the reset pin internal circuit. However, there are a couple of mistakes; the following figure shows the corrected version. The **inverter** at the Reset State Machine’s Trigger input and the **OR gate** at the SET input of the latch are the corrections to this figure.
