Pentium[®] II Processor Specification Update

Release Date: January 1999

Order Number: 243337-022

The Pentium[®] II processor may contain design defects or errors known as errata which may cause the product to deviate from published specifications. Current characterized errata are documented in this Specification Update.

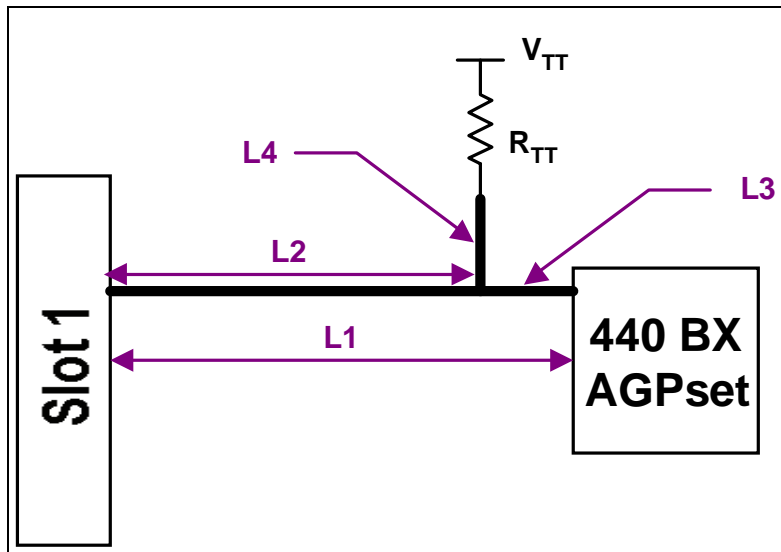
Figure 1. UP Dual Ended Termination (DET)

For UP-DET topologies (see Figure 1), the trace length L1 must be between 1.5" to 4.5" while using a 56Ω termination resistor.

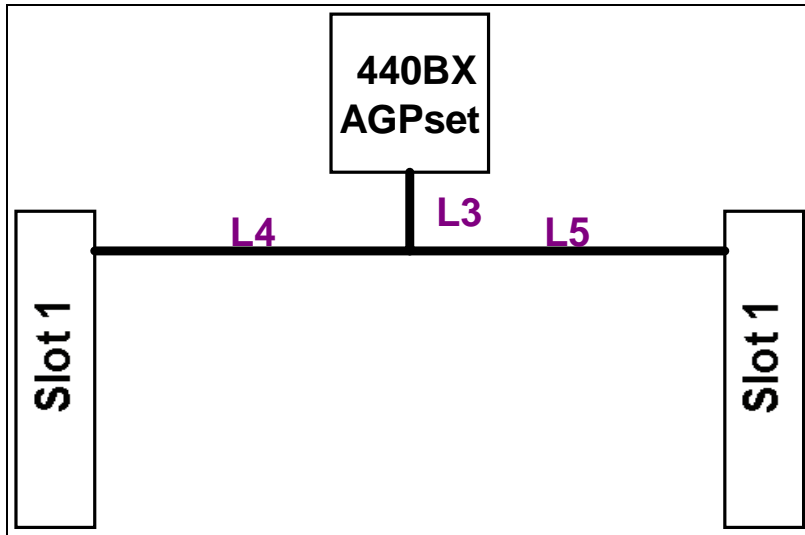
Figure 2. DP Dual Ended Termination (DET)

For DP topologies (see Figure 2) installed with a processor and a termination card, $L4 + L3$ or $L5 + L3$ must be less than or equal to 4.5". Additionally, for DP platforms with one processor installed, the termination card should be placed in the longer leg.

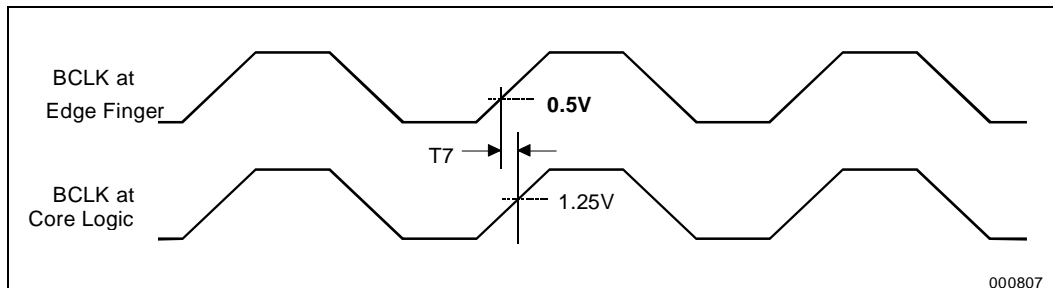
Figure 6. BCLK to Core Logic Offset

In Figure 6 of the *Pentium® II Processor at 233 MHz, 266 MHz, 300 MHz, and 333 MHz* datasheet, the following changes should be made:

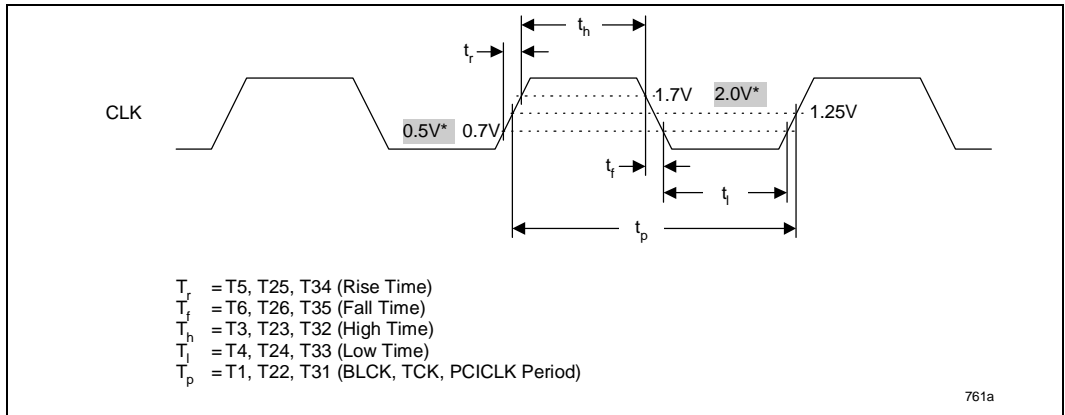
Figure 7. BCLK*, PICCLK, and TCK Generic Clock Waveform

In Figure 7 of the *Pentium® II Processor at 233 MHz, 266 MHz, 300 MHz, and 333 MHz* datasheet, the following changes should be made:
