Verification, Characterization, and Debugging of the HP PA 7200 Processor

To guarantee a high-quality product the HP PA 7200 CPU chip was subjected to functional and electrical verification. This article describes the testing methods, the debugging tools and approaches, and the impact of the interactions between the chip design and the IC fabrication process.

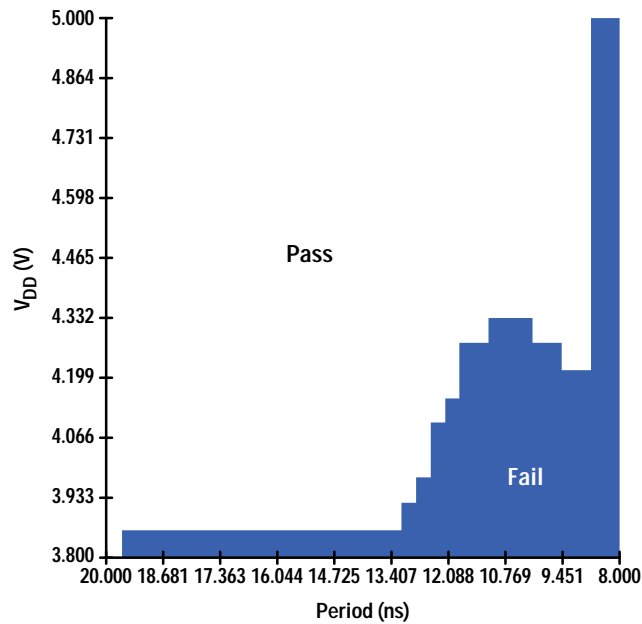
Fig. 3. *Voltage-frequency shmoo plot.*

Shmoo testing involves creating voltage-frequency plots (shmoo plots) by running test code at many voltage-frequency-temperature combinations. Fig. 3 shows a typical style of shmoo plot. This plot is for a failing chip that has some speed problems. By examining the shape of the shmoo plot, much can be learned about the design of the chip. Voltage–frequency– temperature points well beyond the legal operating range should be included in the shmoo plot. It is not sufficient to rely only on the minimum allowed margin (in terms of voltage-frequency-temperature) to determine if the design is robust. The test code run for creating shmoo plots is extremely important. Simple code can create a false sense of quality.

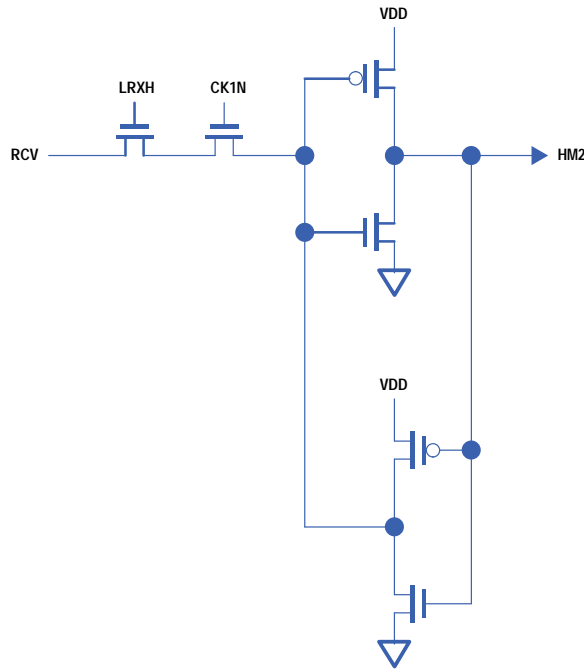
Fig. 5. *A latch circuit that was failing at 5.1 volts.*

These points can be illustrated with a case study. The nominal operating point of the PA 7200 is 120 MHz at a V_{DD} of 4.4 volts. In this particular example, a failure occurred while running a pseudorandom test at 5.1 volts and 120 MHz at high temperature (55°C ambient). Even though the PA 7200 is not required to operate at this voltage the verification team did not expect this failure. Thus, this problem needed to be characterized and its root cause understood.

In this example, this chip was the only one that failed at 5.1 volts. However, a few other chips failed at even higher voltages. This problem was worse at higher frequencies and higher temperatures. The test code that was failing was converted from pseudorandom system code to tester code. Next the test code was run on the tester and analyzed. Since this problem did not occur at lower frequencies, each phase of the clock in the test was stretched to determine which clock phase made the chip pass or fail. The internal state of the chip was also dumped out on the tester using serial scan. The failing and passing internal scanned states were compared to see which states were improperly set. This helped to isolate the failing path. Once this was done, the failing path for this failure was analyzed to understand the electrical failing mechanism. For this problem, E-beam was used to understand the failing mechanism.

Fig. 5 shows the circuit that was failing in this debugging example. The circuit is a latch with the signal LRXH controlling the transfer of data into the latch. When LRXH and CK1N (clock) are true (logic 1), the latch is open and the inverted level of the input RCV gets transferred to the output HM2. When LRXH is false (logic 0), the latch is closed and the output HM2 holds its state.

In this case study, the worst-case test caused many parts to fail at nominal conditions. The failing mechanism was modeled in a circuit model by the designer. Once this was done, a fix was developed. FIB was used to verify the fix. This failure mechanism was fixed by speeding up LRXH by adding a buffer to the long route of LRXH. Fig. 7 shows how this was done. The figure is a photograph of a die that was FIBed to buffer the LRXH signal. To do this, the long vertical metal 3 wire on the right side of the figure was cut with the FIB process and a buffer was inserted. A buffer was available on the left side of the figure; however, metal 3 covered this buffer. The FIB process was used to etch the metal 3 area surrounding the buffer to expose the metal 2 connections of the buffer. The FIB process was then used to deposit metal to connect the metal 2 of the buffer to the vertical metal 3 wires. The FIBed chip was then tested to make sure that the failing mechanism was fixed.

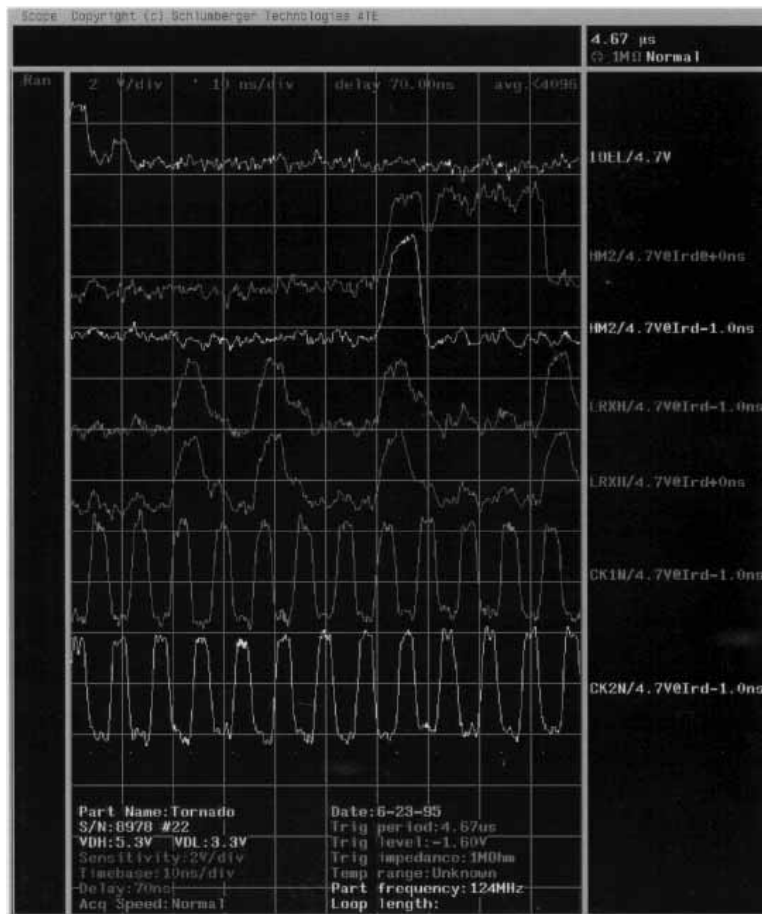
Fig. 6. *Waveforms of the internal signals of the failing latch circuit, captured by electron-beam probing.*

Fig. 6 shows the waveforms of the internal signals that were captured through E-beam. The last two signals, CK1N and CK2N, are the two-phase clock signals on the chip. The passing and failing waveforms for LRXH and HM2 are shown at the top of the figure. The passing waveforms for LRXH and HM2 are called LRXH/4.7V@Ird+0ns and HM2/4.7@Ird+0ns, respectively. The failing waveforms for LRXH and HM2 are called LRXH/4.7V@Ird−1.0ns and HM2/4.7@Ird−1.0ns, respectively. The input signal RCV (not shown in the figure) is 1 during the first two pulses of LRXH shown, 0 during the third pulse, and 1 thereafter. The output HM2 is expected to transition from 0 to 1 during the third LRXH pulse and stay 1 until the fourth pulse. However, the slow falling edge on LRXH causes a problem. In the failing case, on the third LRXH pulse, HM2 transitions from 0 to 1 but the slow falling edge on LRXH also lets the next input value of RCV (1) propagate to the output HM2. HM2 therefore transitions back to 0. In the passing case, the falling edge of LRXH arrives a little earlier and the output HM2 maintains what was captured in the latch (1). Once the failing mechanism was understood, the worst-case test was developed.

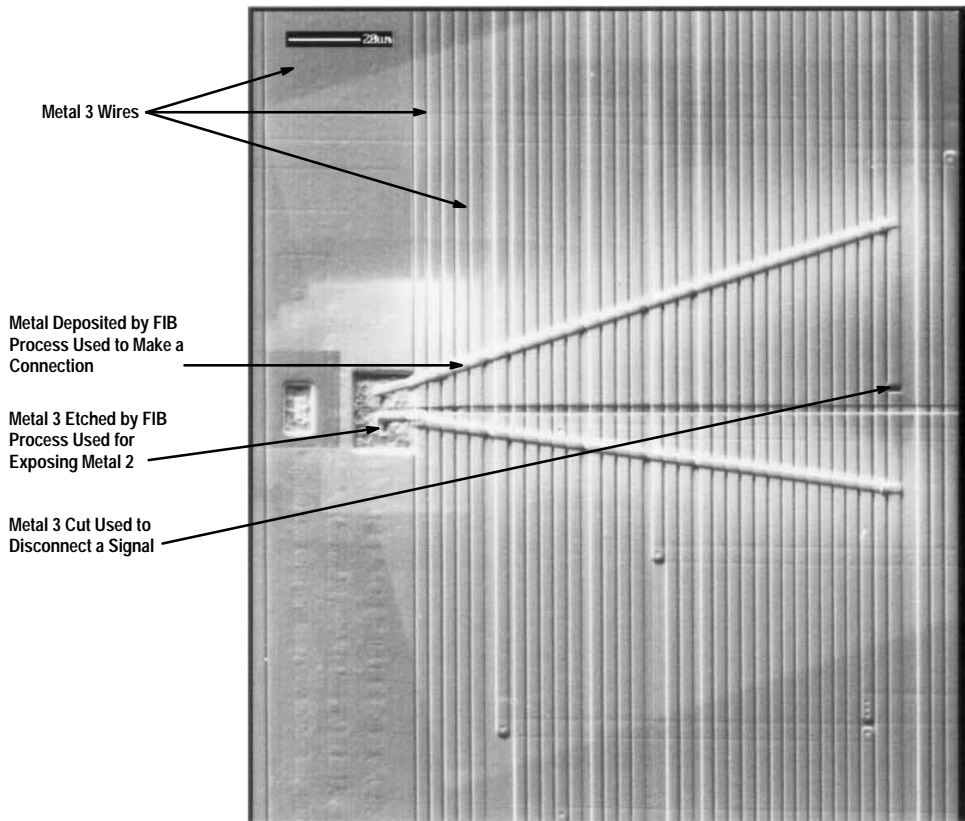
Fig. 7. Once the latch problem was found and a fix developed, the fix was verified by modifying one die using a focused-ion-beam (FIB) process. The long vertical metal 3 wire on the right was cut with the FIB process and a buffer was inserted. A buffer was available on the left side of the figure; however, metal 3 covered this buffer. The FIB process was used to etch the metal 3 area surrounding the buffer to expose the metal 2 connections of the buffer. The FIB process was then used to deposit metal to connect the metal 2 of the buffer to the vertical metal 3 wires. The FIBed chip was then tested to make sure that the failing mechanism was fixed. Photo courtesy of FAST (FIB Applied Semiconductor Technology), San Jose, California.

Since a chip turn to determine whether the fix will work and that the fix has no side effects takes a long time, the fix can often be verified with a focused-ion-beam (FIB) process. *FIBing* is a process by which the chip's internal connections can be modified, thereby changing its behavior or functionality. In the FIB process, metal wires can be cut, or joined by metal deposition. FIB is an extremely valuable tool to verify fixes before implementing them in the actual design.
