# **Pentium® II Xeon™ Processor Specification Update**

Release Date: February 1999

Order Number: 243776-010

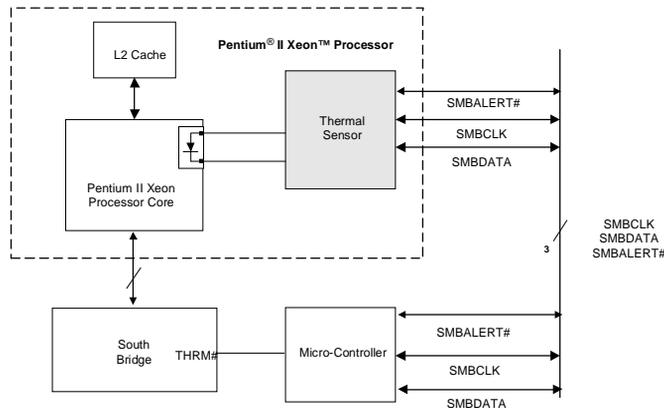
**Figure 1. An Example of Microcontroller Driven Thermal Management**

### D30. Thermal Sensor May Assert SMBALERT# Incorrectly

**PROBLEM:** The Pentium II Xeon processor has a thermal sensor that monitors the processor core's temperature. The thermal sensor asserts SMBALERT# if the processor temperature exceeds the temperature limits set in the Alarm Threshold Registers ( $T_{HIGH}$ ,  $T_{LOW}$ ). It also sets the corresponding Status Register bits to identify the cause of the interrupt. Figure 1 gives one example of the how the SMBALERT# signal could be used in a system.

Under the conditions described below, the thermal sensor incorrectly generates the SMBALERT# interrupt. *All* of the following conditions must be met to trigger a false interrupt:

1. Before servicing an interrupt from the thermal sensor, read and compare the processor thermal reading with the threshold limits ( $T_{HIGH}$  or  $T_{LOW}$ ). Figures 2 and 3 provide basic flowcharts for the implementation of this workaround in an interrupt driven system.
2. If the firmware implemented polls the Status Register only, then before taking any action, re-read the temperature register and do a comparison with the alarm threshold limits ( $T_{HIGH}$  or  $T_{LOW}$ ) to determine if the value is actually still within the temperature window.
3. Use a temperature polling scheme to monitor the processor temperature.
