Mobile Pentium® II Processor Specification Update

Release Date: April 1999

Order Number: 243887-009

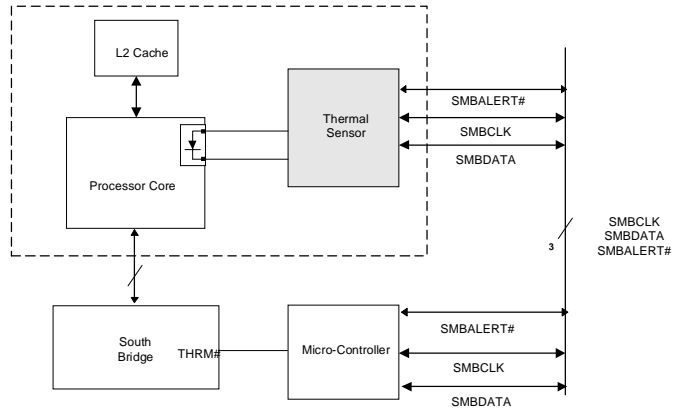
Figure 1. An Example of Microcontroller Driven Thermal Management

B30. Thermal Sensor May Assert SMBALERT# Incorrectly

PROBLEM: The Mobile Pentium II processor and the Pentium II Processor Mobile Module have a thermal sensor that monitors the processor core's temperature. Please note that desktop systems could have a similar thermal device. The thermal sensor asserts SMBALERT# if the processor temperature exceeds the temperature limits set in the Alarm Threshold Registers (T_{HIGH}, T_{LOW}). It also sets the corresponding Status Register bits to identify the cause of the interrupt. Figure 1 gives one example of the how the SMBALERT# signal could be used in a system.

Under the conditions described below, the thermal sensor incorrectly generates the SMBALERT# interrupt. *All* of the following conditions must be met to trigger a false interrupt:
