Mobile Pentium® II Processor Specification Update

Release Date: November 1999

Order Number: 243887-015

The Mobile Pentium® II processor or the Intel® Pentium® II Processor Mobile Module may contain design defects or errors known as errata which may cause the product to deviate from published specifications. Current characterized errata are documented in this Specification Update.

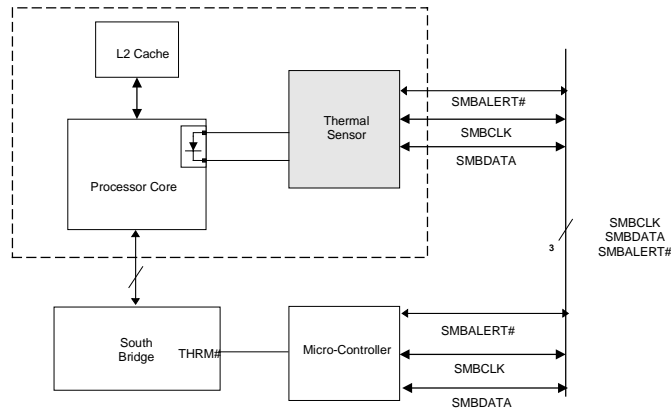
Figure 1. An Example of Microcontroller Driven Thermal Management

Problem: The Mobile Pentium II processor and the Pentium II Processor Mobile Module have a thermal sensor that monitors the processor core's temperature. Please note that desktop systems could have a similar thermal device. The thermal sensor asserts SMBALERT# if the processor temperature exceeds the temperature limits set in the Alarm Threshold Registers (T_{HIGH} , T_{LOW}). It also sets the corresponding Status Register bits to identify the cause of the interrupt. Figure 1 gives one example of the how the SMBALERT# signal could be used in a system.

Under the conditions described below, the thermal sensor incorrectly generates the SMBALERT# interrupt. All of the following conditions must be met to trigger a false interrupt:

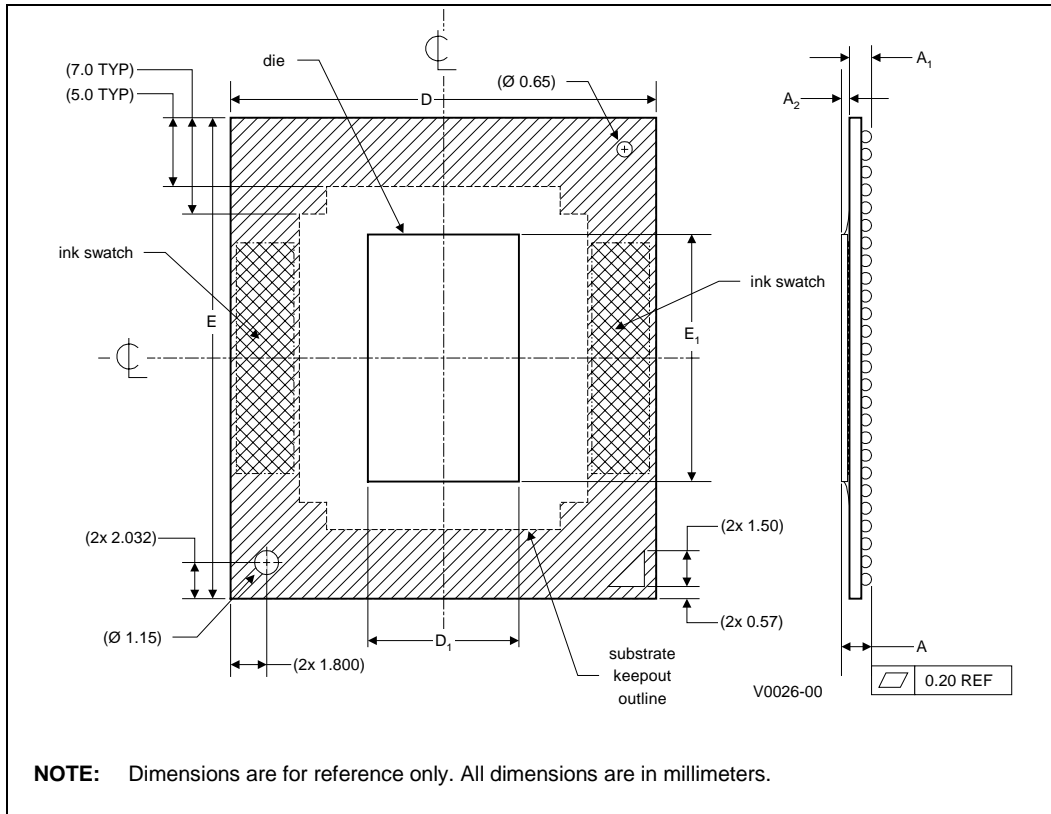
Figure 5.3. Surface-Mount BGA1 Package—Top and Side View

The following table and figures show the updated mechanical specifications for the BGA1 package, listed as Table 5.2, Figure 5.3 and Figure 5.4, respectively, in the *Mobile Pentium® II Processor in BGA Package at 366 MHz, 333 MHz, 300PE MHz, and 266PE MHz* datasheet.

1. The number shown here is different from that in the 243887-010 revision of this specification update. The maximum reference number is used.
