8XC196KC SPECIFICATION UPDATE

Release Date: May, 1997
Order Number: 272834-004

The 8XC196KC may contain design defects or errors known as errata. Characterized errata that may cause the 8XC196KC's behavior to deviate from published specifications are documented in this specification update.

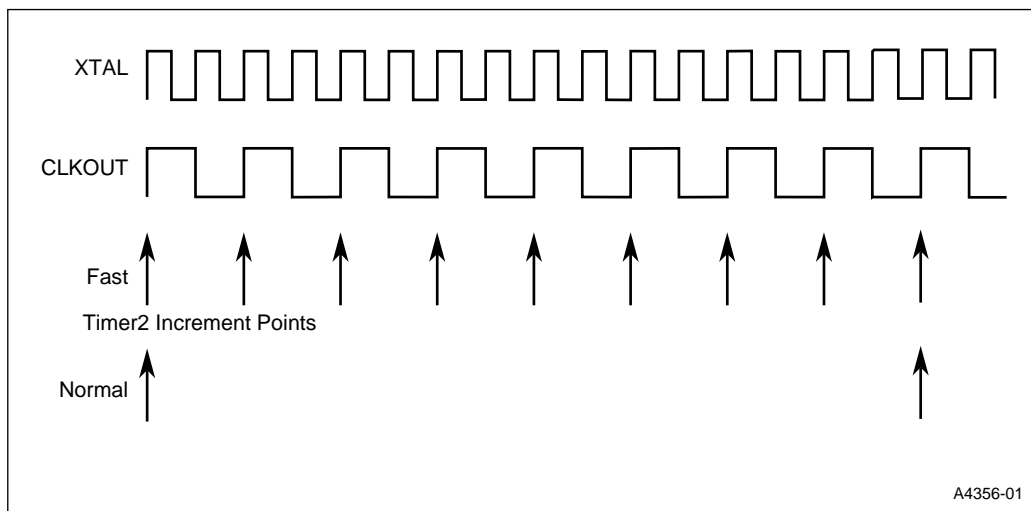
PROBLEM: Confusion has arisen regarding the fourth paragraph of Section 8.1.3.1. The following paragraph clarifies this text:

When FAST_T2_ENA is set (fast increment mode), Timer 2 increments once every state time, at the rate of $F_{osc}/4$. When FAST_T2_ENA is cleared (normal increment mode), Timer 2 increments once every eight state times, at the rate of $F_{osc}/32$. See the timing diagram below for a depiction of the input clock signal, the CLKOUT signal, and the points at which Timer 2 increments in the fast and normal modes.

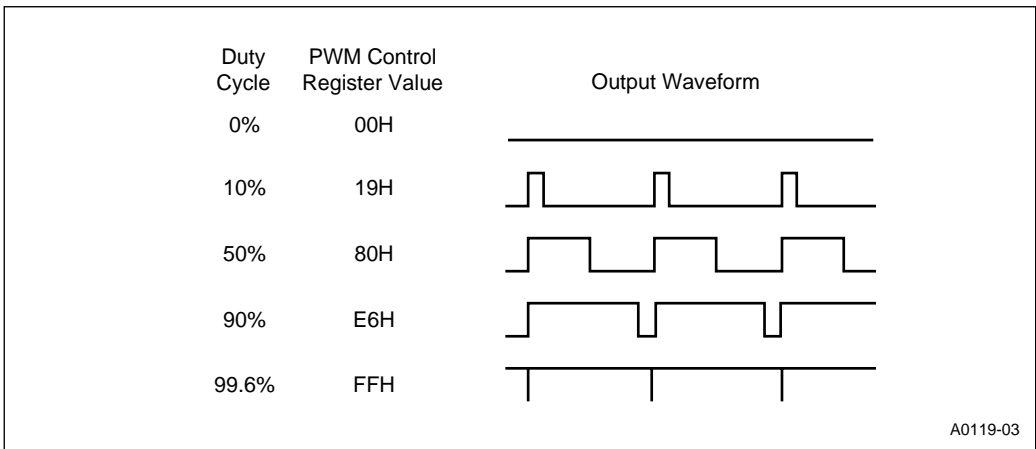
The following figure replaces Figure 10-2.

PROBLEM: Add the following sentences to the second paragraph after the first sentence: 'Since the value written to the control register is buffered, you can write a new 8-bit value to PWMx_CONTROL before the counter overflows. The new value is used during the next period of PWMx.'

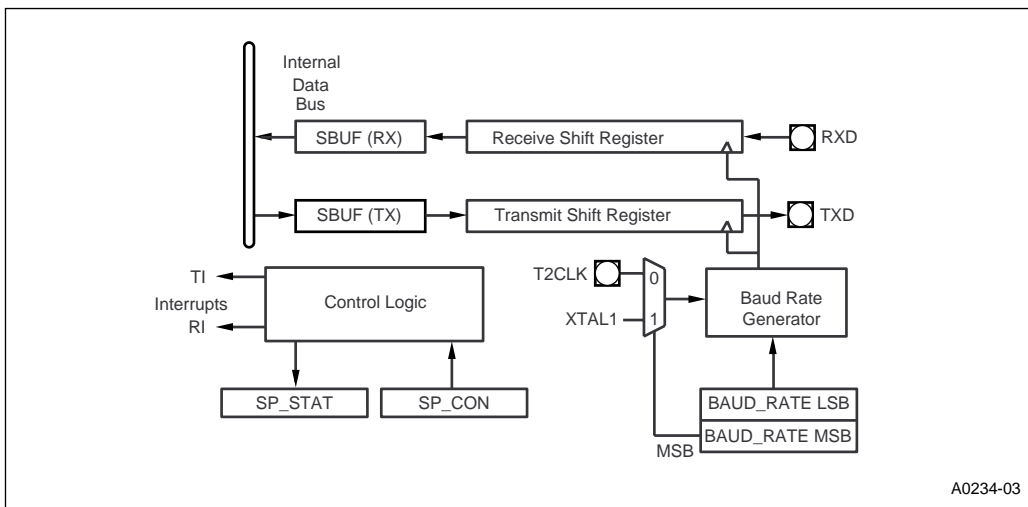
Figure 4. Serial Port Block Diagram

ITEM: The following block diagram will be included in future manuals.

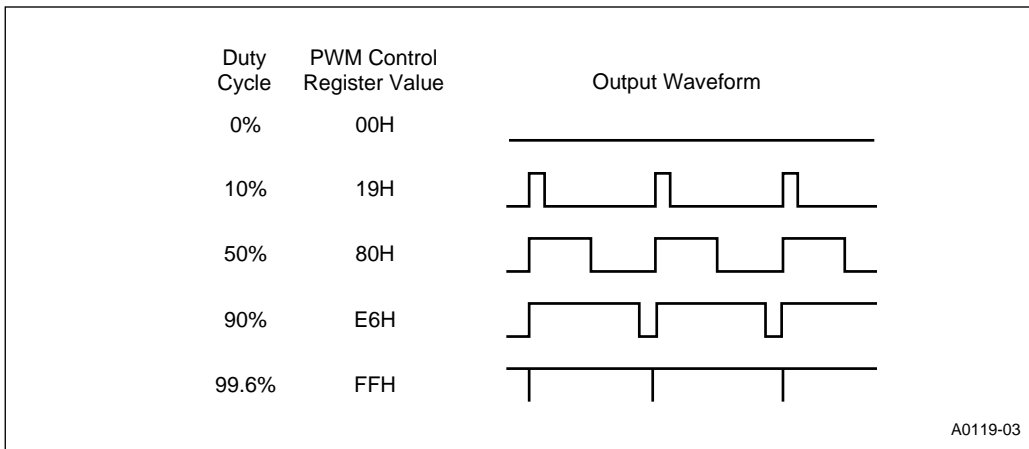
The following figure replaces Figure 10-2.

ITEM: On page 10-2, add the following sentences to the second paragraph, after the first sentence: 'Since the value written to the control register is buffered, you can write a new 8-bit value to PWMx_CONTROL before the counter overflows. The new value is used during the next period of PWMx.'
