Intel® Celeron™ Processor Specification Update

Release Date: March 1999

Order Number: 243748-013

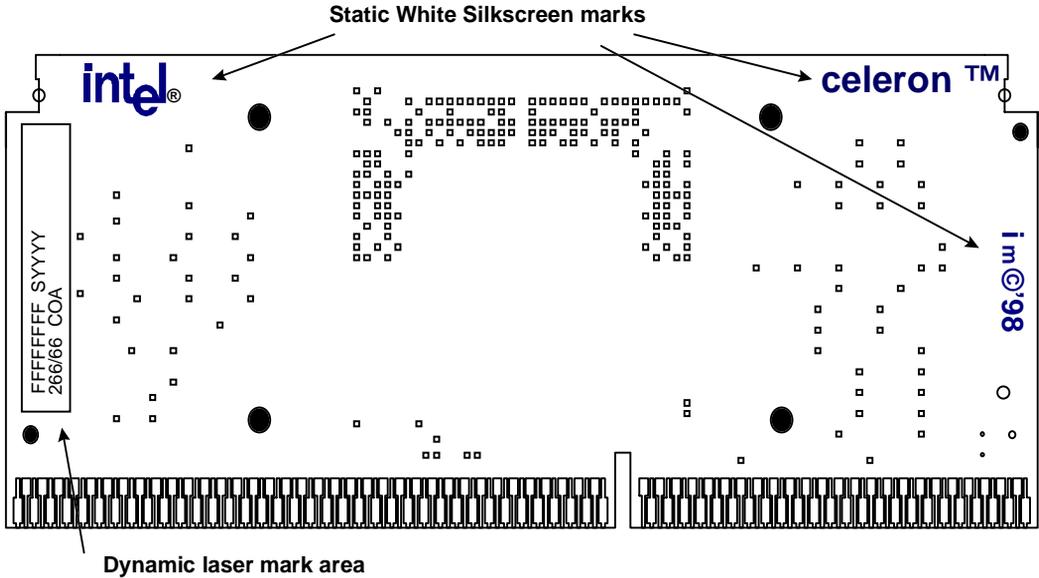
Intel® Celeron™ Processor and Boxed Intel® Celeron™ Processor Markings (S.E.P. Package)

- SYYY = S-spec Number.
- FFFFFFFF = FPO # (Test Lot Traceability #).
- COA = Country of Assembly.
