Pentium® III Xeon™ Processor Specification Update

Release Date: April 1999

Order Number: 244460-002

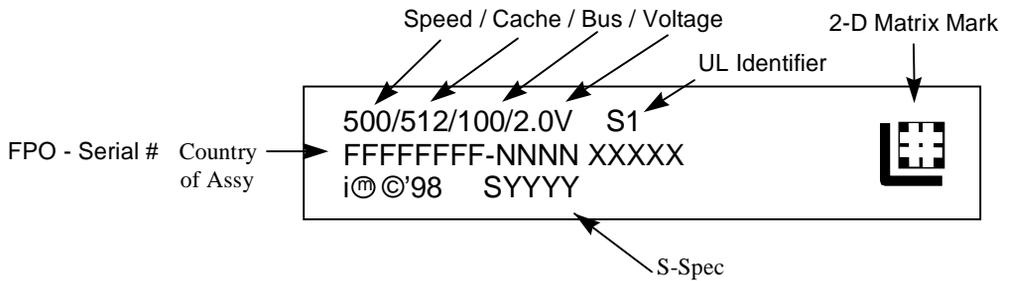
Production Dynamic Mark Example:

Intel 80525PY500512
 FFFFFFFF-NNNN

Dynamic Mark Area
