Pentium[®] III Processor Specification Update

Release Date: November 1999

Order Number: 244453-009

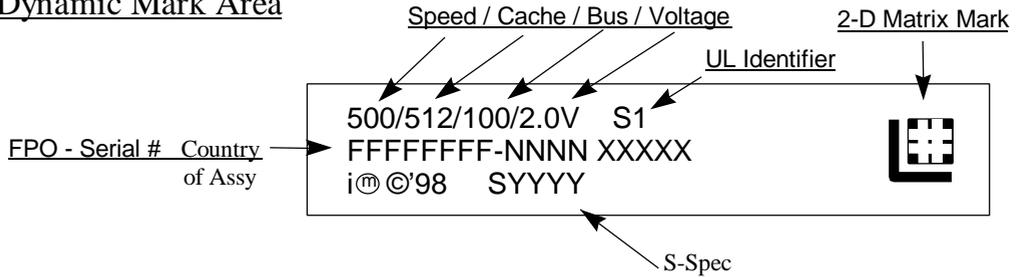
Pentium III Processor and Boxed Pentium III Processor 3 Line Markings

Dynamic Mark Area
