# **80C196NU, 83C196NU SPECIFICATION UPDATE**

Release Date: July, 1997  
Order Number: 272864-003

The 80C196NU, 83C196NU may contain design defects or errors known as errata. Characterized errata that may cause the 80C196NU, 83C196NU's behavior to deviate from published specifications are documented in this specification update.

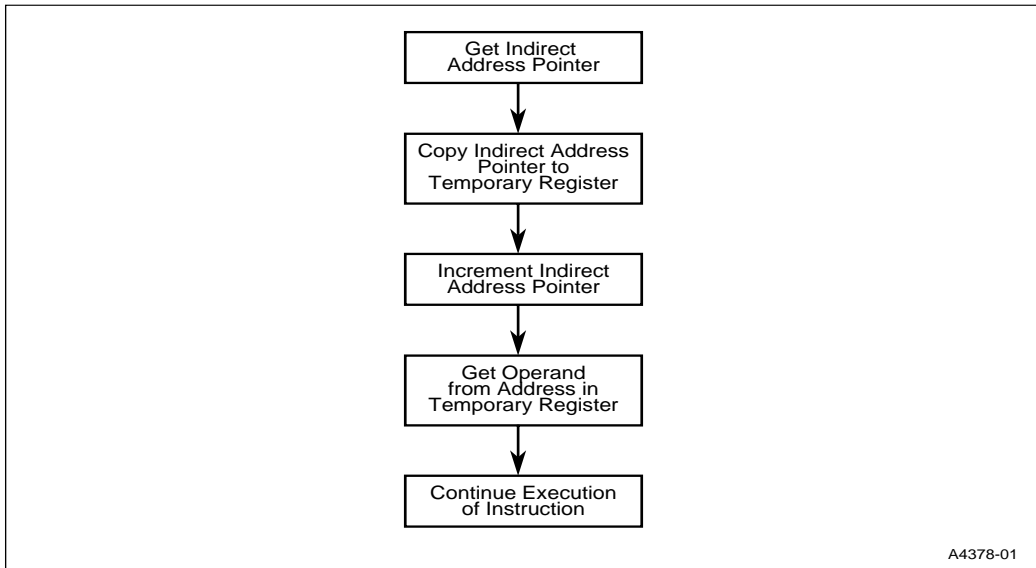
The CPU stores the pointer's value in a temporary register, increments the pointer, then accesses the operand at the address contained in the temporary register, as shown in this flowchart.

Therefore, if the pointer points to itself, the CPU accesses the operand at the incremented address contained in the pointer.

**PROBLEM:** For indirect addressing with autoincrement, a pointer that points to itself results in an access to the incremented pointer address rather than the original pointer address.
